# Barn Tour

*Saucon Valley Conservancy Barn Tour September 12, 2009*

## Preservation of the Heller Barn

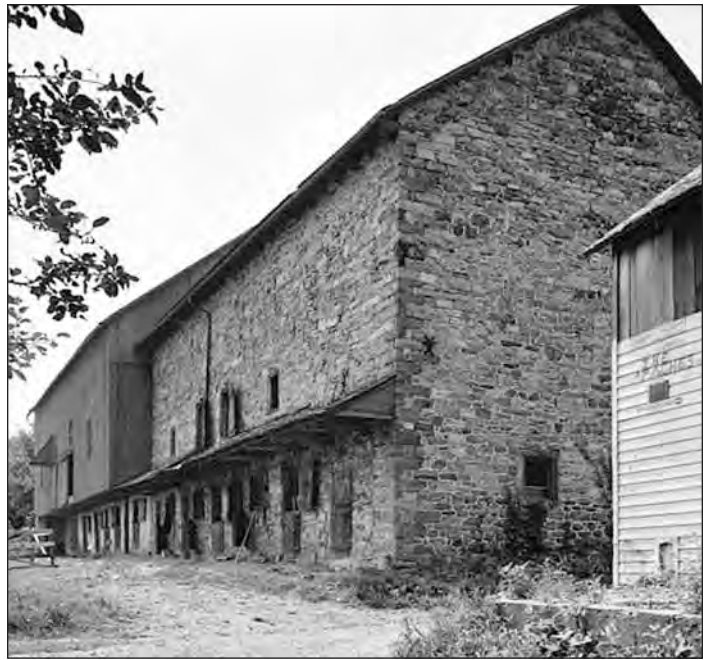
*This is the original early 1940s photo of the Heller homestead barn complex, a circa 1790 English Lake District barn with a stone addition. An unusual front wall stone arch existed at the north end and a large Civil War era frame section was at the south end.*

The original section of the Heller homestead stone barn at the Friedensville Road historic site was a rare local English Lake District type bank barn. One timber ostensibly from the original barn section was dendro-dated in the spring of 2009 and it appears that the barn was quite likely built in the 1790 to 1800 era. This barn is in distinct contrast to the far more common Standard “forebay” bank barn seen in Lower Saucon Township and countless other areas in southeast Pennsylvania and beyond. The Heller barn actually had two sections, an earlier two part stone section at the north end and a much later frame section at the south end of the barn complex.

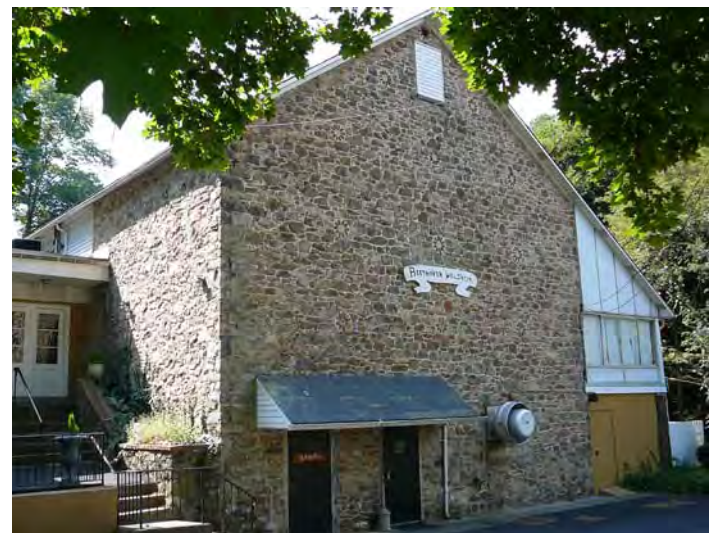
Standard Barn, circa 1840

The Waldheim structure, as a Standard barn, fulfills all the basic requirements of such a class of barn. But as an extra added spice to the variety of barn structures in the township, the Waldheim barn has one unusual twist in its appearance. Both gable walls to the peaks and rear wall (exclusive of the wagon doors) are all stone, but they have incorporated into the fabric of the masonry walls at pre-determined spots which are called in the parlance – **circular loop-holes**. Its close cousin, vertical ventilator slits or splayed loop-holes, are seen in several other barns in the township. Circular Loop-holes are outlined in brick, about nine or ten in number, and the usual diameter of the opening is about nine inches or so. They are arranged in several rows at each gable wall. Some barns may have up to fifteen to twenty or perhaps more on each gable wall. In the Waldheim barn, loop-holes appear on both the gable walls and the rear wall.

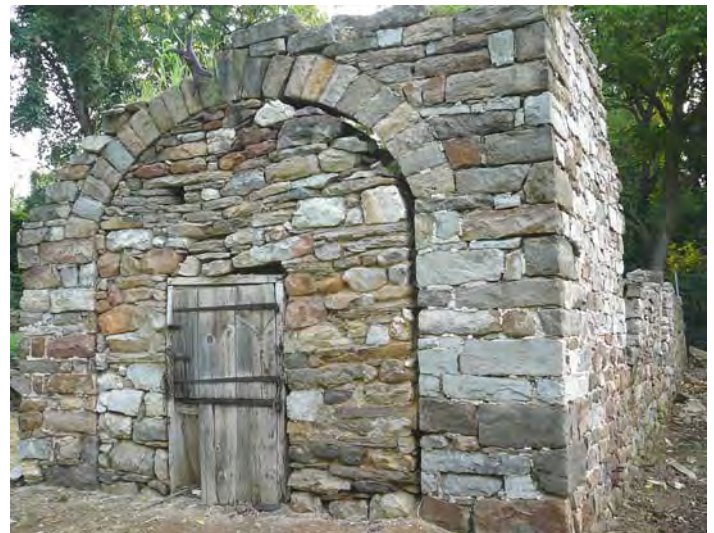
English Lake District bank barn, Original Stone Barn Section, Dendro-dated to circa 1790

a portion of the roof collapsed. Deeming it a danger, township officials decided to bring down all but about one-third of the barn. Fortunately, what was saved of the barn was the very unusual stone arch of the non-original north end addition.

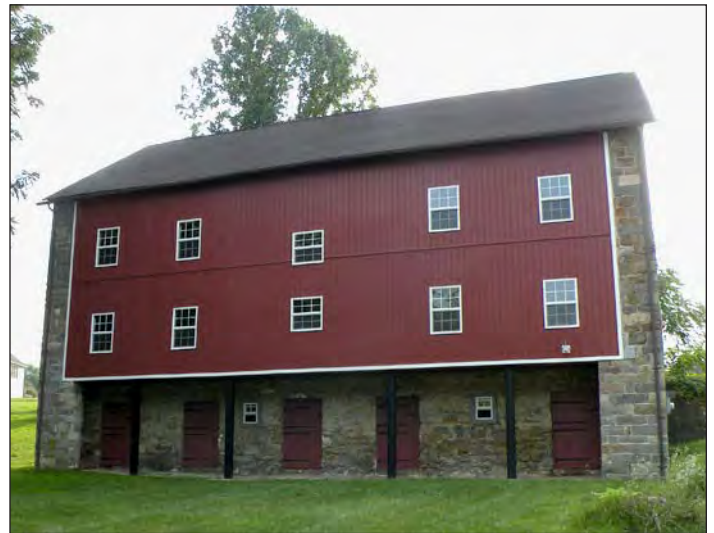
Stone Standard barn, dated 1851

On the south side of Walnut Street (Skibo Road) in Lower Saucon Township is the dated 1851 Wagner stone to peak Standard barn. It is slated to become a home by the Gatchel family who is the current owner. The barn has exterior dimensions that are medium sized at 37 ½ feet wide by 60 feet long. The front fore-bay wall faces about five degrees south of east and is now covered with metal. The rear wall has unusual old decorative style painting above the main wagon doors that consists of two semi-circles. On each stone end wall, just under the peak, is a not often seen brick lined semi-circle several feet in diameter.

The barn is of three-bay construction. The wagon bay is 15 feet wide and each end bay is close to 21 feet wide. Here again is seen yet another Principal Rafter System with four Principal Rafter trusses. In this example, the Principals are large. In each end bay is a mid-span truss. Each truss originally had a collar beam where only one now remains. Common rafters are milled and have the arrangement – 4-3-5-3-4. In the middle bay, there's a unique triple tiered purlin plate seen in each roof slope. Far more commonly seen are double tier plates as is seen in the end bays in the Wagner barn.

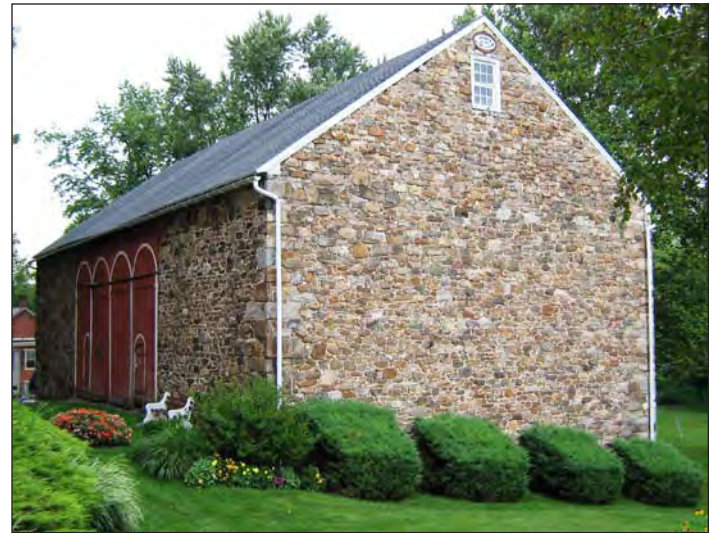
Stone Standard barn dated 1849

This dated 1849 Stone Standard barn located on Meadows Road, a little west of Saucon Creek, has no rival in sheer size compared to the other barns on the 2009 tour. Standard barns are two level banked barns that have symmetrical roofs, that is, each roof slope per half of the total roof are equal in lengths. In addition, Standard barns have recessed stable walls such that the overhead basement ceiling joists or beams cantilever over and beyond the sill at the top of the stable wall. The vast majority of barns in Northampton County are Standard barns.

Stone appears to the peak at each end wall in the Wagner barn. This is a very well constructed barn. The front or “fore-bay” wall basically faces the southeast quadrant as is the case with the majority of bank barns in southeast Pennsylvania. Much or most of the one

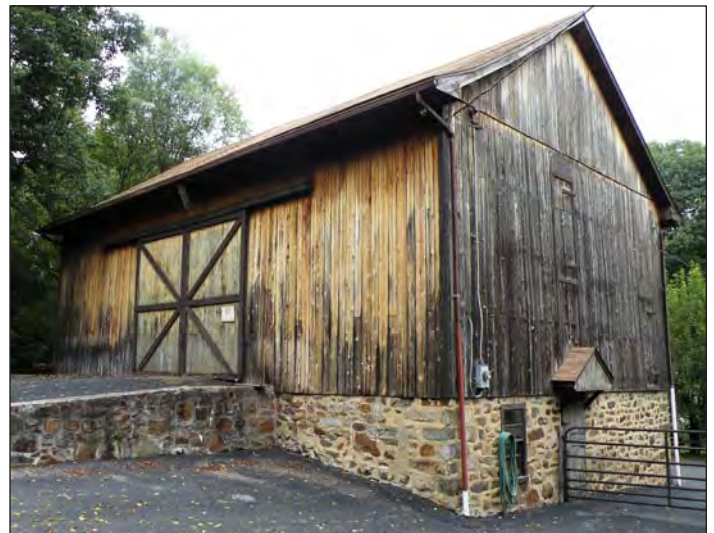
Frame Standard barn, circa 1825

The barn is a three-bay structure and at 48 ½ feet by 32 feet in dimension and is small to medium sized. The front fore-bay wall faces due east. No original siding remains on the exterior. A peiler eck appears at each front corner of the barn on the foundation level. Originally, there were five stable wall doors where only three door entries presently survive, as well as a several foot long sliding door that appears on the wall.

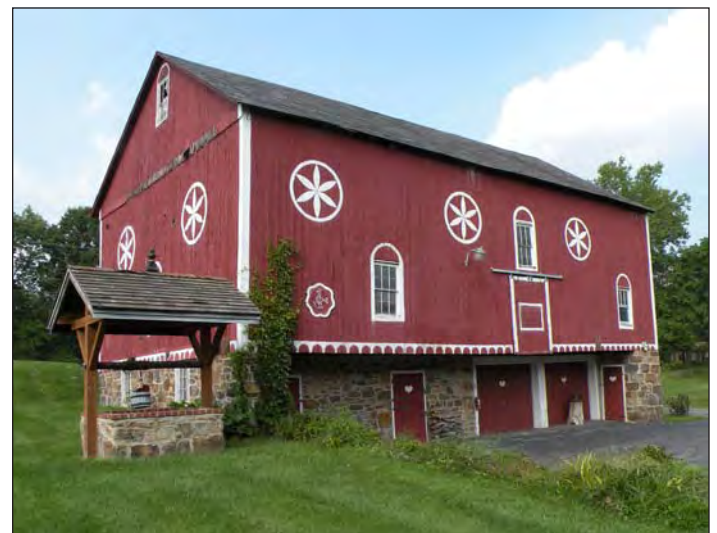
Frame Standard barn - original two-section part, circa 1860 – and one-bay addition – 1890’s

A two-section frame Standard barn with a later rear frame lean-to addition stands on the north side of Easton Road in Lower Saucon Township. The original barn section has two bays and one bay was added at the west end of the barn. The two-bay part was built around the time of the Civil War and the one bay section might have been built in the 1890s since there is a painted date on the front fore-bay wall. The two sections together are 50 ½ feet in length by 30 ½ feet wide. The rear frame addition is 14 ½ feet wide by 30 ½ feet long. The front wall of the two-section barn complex faces thirty degrees west of south. The roof is covered with slate. A *peiler eck* is seen at each front wall corner at the basement level. The *peiler eck* at the southeast corner is wide to accommodate a “closet” area for elements incidental for the use and care of farm horses. The fore-bay wall projects 4 ½ feet beyond the stable wall.

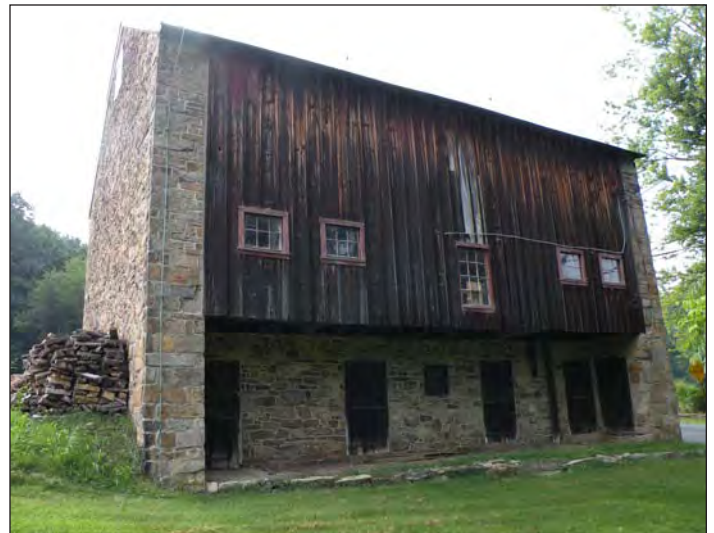
Stone Standard circa 1840

At the end wall closer to Alpine Drive, a single door entry appears that leads into the feed alley adjacent to the horse stable area in the basement. As is almost always seen on Standard barns on their far end walls, no door entrances appear. This is a three-bay constructed barn with a middle wagon bay and two end bays. The middle bay is 14 feet wide and each end bay is a few inches more than 14 feet wide.

Another Principal Rafter system is seen. A Principal Rafter truss is seen in line with each bent that flanks the middle bay so that a total of two trusses appear in the barn. A double tier system of purlin plates are

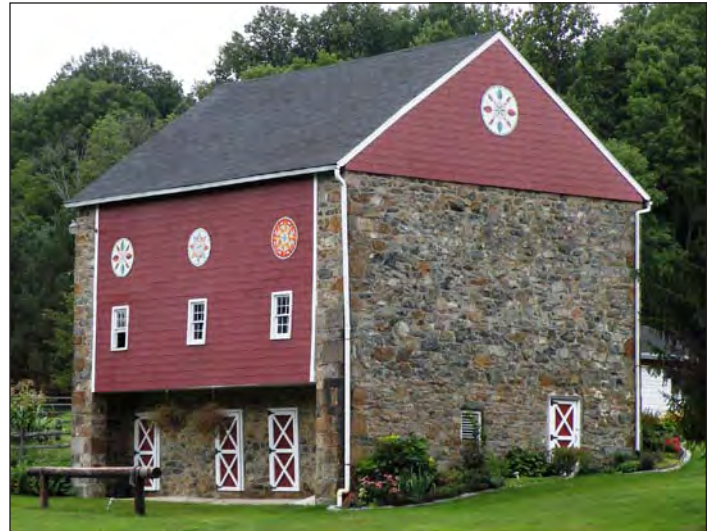
Standard bank barn, Circa 1830

This beautiful picture post card barn located on Lower Saucon Road less than a half mile below the four corners of Wassergass is the smallest barn on the tour at only about 33 feet at the front wall and about 27 feet at each end wall. The barn, however, is in excellent condition and is very well maintained. This barn of three-bay construction likely dates to circa 1830. It is a stone to the peak (originally) Standard bank barn. There are four stable wall door openings. The doors are not original but the door frames are original and may be chestnut. As is typically found, there is a feed alley door entry at the end wall closer to the homestead house. In the great majority of Pennsylvania bank barns the horse stabling area in the basement was closer to the house end. This may have been due to the fact that the farm lane was closer to the house and there was a greater need of accessibility for horses to be stabled toward the house end of the barn. Cows were most often stabled away from the house end. This was very likely the case in the Robertson barn in most of the nineteenth century and likely into the next century.

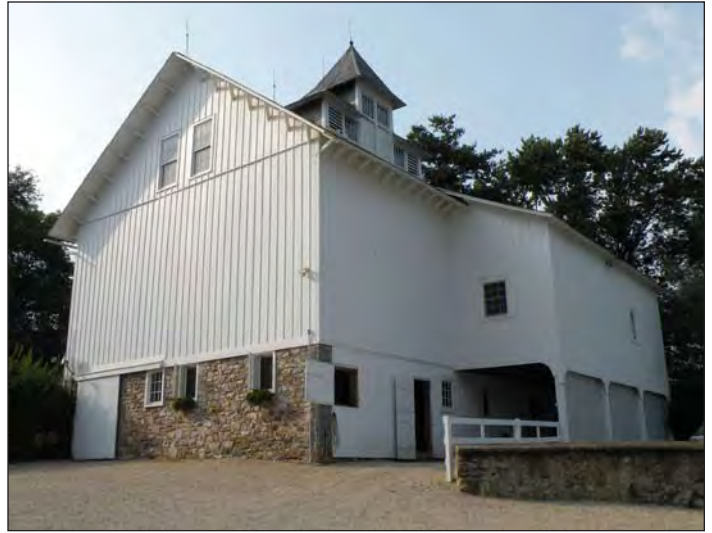
Frame Standard barn built 1898-1900

The only barn outside of Lower Saucon Township that appears on Route 412 in extreme northern Bucks County is cavernous in size to say the least. It is of frame construction and the exterior dimensions are 62 feet on the long side and 37 feet at each end wall. The barn appears to have all its original vertical exterior siding. There are original roof edge over-hangs at all four walls and the Italianate like support braces are original and quite unusual. A three-section cupola is seen centered on the roof ridge. The barn is in excellent condition and is currently used for stabling horses in the basement. At the barn front, a frame addition appears which is open at the bottom and about 40 feet long by 12 feet wide.

The top floor level reveals three-bay construction and its upper reaches appear to nearly touch the heavens. It is a marvel of late nineteenth century construction technology. Same sized milled rafters un-pegged at the top are seen that are supported by barn length purlin plates. A remarkable construction feature appears in each end bay where canted braces stretch from purlins to side wall plates. They are seen two per bay per barn side for a total of eight in the barn. Another very rare feature is a timber seen about seven feet below the roof ridge set longitudinally from end wall to end wall.

This barn has a feature almost never seen in pre Civil War Standard barns – internalized posts that run from the floor all the way to the roof. The barn has yet another very rare feature where the floor boards (or planks) run transversely or front to back in the barn. Almost always, such boards in other barns run longitudinally or side to side.
