# Barn Tour

*Saucon Valley Conservancy Barn Tour September 15, 2007*

## Preservation of the Heller Barn

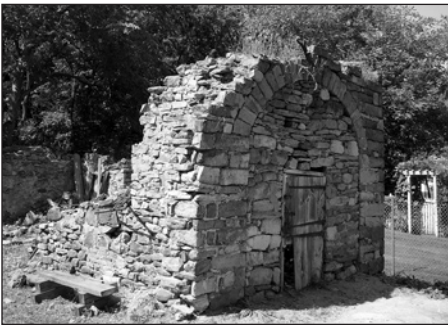
### **English Lake District bank barn, Original Stone Barn Section, Circa 1790**

The original section of the Michael Heller homestead stone barn at the Friedensville Road Historic Site was a rare local English Lake District type bank barn. It was likely built circa 1790. This barn with a front wall fully of stone construction and first story front wall protective pent roof is in distinct contrast with the far more common Standard “fore-bay” bank barn. These latter barns are very often seen in Lower Saucon Township and countless other areas in southeast Pennsylvania and beyond. The Heller barn actually had two sections—an earlier two part stone section at north and a much later frame section at south end of barn complex.

The roof of the first built stone barn section was deteriorating to quite a degree in the early 1990s. Ultimately the last existing remnants of the Heller barn were its exterior stone walls that were pulled down by the township in early 1998 for safety reasons. Presently, only remnant timbers are lying about on the former dirt floor of the basement of the barn. Fortunately what was saved of the barn was the very unusual stone arch of the non-original north end addition. However English the barn was on its exterior, especially on its fully stone front wall, its original roof structure was clearly German in expression—a *liegender Stuhl*. Photos of this superb Heller barn early roof survive.

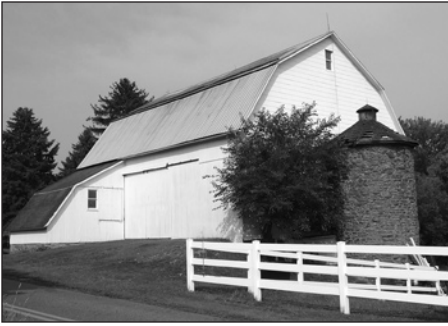
### 3 - Haney Farm

#### **Stone silo and a gambrel roofed frame bank barn, Silo, Circa 1880**

The Rod Haney homestead on Drifting Drive features among other farm outbuildings is an excellent and rare stone silo. Most other silos in southeast Pennsylvania are made of other materials such as poured concrete, metal, ceramic and sometimes even wood slats. Silos are thought to have first appeared on the American landscape in the 1870s in the mid West. The Haney silo was very likely built in the last quarter of the nineteenth century.

The silo has a fascinating history. It is actually credited as basically an American invention. Mid nineteenth century farmers apparently borrowed from the design of corn cellars that were constructed by Native Americans since the 1700s. They lined a trench or ditch with stone and ash, filling the resulting enclosure with green crops, and then covered the cellar with beans and thatch. It is very interesting that the basic American silo design came on the cultural landscape when it did. It is thought that some of the very first silos were built as integral units inside of barns and such instances survive on certain farms. As seen on the Haney farm stone was used in the construction of the silo but manufactured materials were used far more often than stone after about 1900. Brick silos date from about the turn of the century and diminished in use by the 1920s. Cast tile and cinder block silos date from this time frame. Then the concrete silo commonly came into being and later metal silos became extremely common in many parts of the United States. In view of the presence of many silos that still can be seen in southeast Pennsylvania, a basically intact stone silo as seen at the Haney farmstead is quite unusual.

At the homestead is likely the latest built barn on the tour—a gambrel roofed frame bank barn. Its roof type reflects a construction date of after 1900. Gambrel roofed barns were very rarely if at all built before about 1880 and there are very few stone gambrel roofed barns originally built as such. The word gambrel refers to two roof slopes per half side of the roof. All other barns at other homesteads on the tour have gable roofs. Gable refers to roofs with only one slope per single side of the roof. Gambrel roofs were often incorporated into structures of barns after 1900 to increase crop storage capacity.

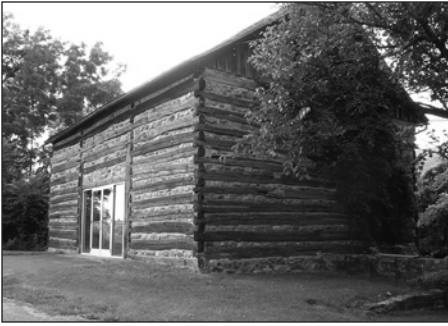
### Log Barn, Circa 1800

The log bank barn at the Rothrock—Eighmy homestead at the intersection of Creek Road and Seidersville Road just over a mile north of the Michael Heller homestead is unique in all of Pennsylvania. This assertion is no exaggeration. All other known remaining log barns in the state are either one-level ground barns or two-level “fore-bay” type Switzer bank barns. Several other dozen log barns have been identified to date in southeast Pennsylvania but only one other log bank barn of possible English origin (without a “fore-bay” or projecting second floor level barn section beyond the stable wall) has ever been discovered. This barn near Devon in Tredyffrin in Chester County dated 1780 was dismantled in late 2000 and was composed of fully round logs in contrast to the Rothrock barn that consists of logs that have hewn sides. The Rothrock barn is also included in the book—*Pennsylvania German Barns*. It was John Heyl himself who photographed the barn in the mid 1950’s. Many years later in 2001, the author photographed John in front of the barn. The Rothrock—Eighmy barn may be the oldest barn on the tour.

The Rothrock barn that likely dates 1790 to 1800 is small in dimensions—only 40 feet at the front wall by 29 feet at each of the end walls. This diminutive size generally reflects its apparent construction date. The excellent homestead stone house across the street in contrast dates to the second decade of the nineteenth century. The logs of the barn exposed on their exterior faces have very weathered surfaces due to direct exposure to the elements since perhaps the barn was originally built. The exterior logs join at their corners in the very traditional local (Lehigh and Saucon Valley) manner with inverted V notching. Several of the original logs or sections or lengths of particular deteriorated logs were replaced with new timbers in the last number of decades.

The interior of the log barn is almost as spectacular as the exterior. The basic construction of the barn is of three bays—two end bays and a middle wagon or threshing bay. Each end bay is somewhat over 12 feet wide while the middle bay is about 14 feet in width. Bays are the areas between an adjacent end log wall and the log wall that flanks the middle bay or the area between adjacent log walls that flank the middle bay. The floor of the middle bay retains much of its original planking. The barn features an unusual early style English based Principal Rafter System where much larger principal rafters co-mingle with considerably smaller common rafters. The log barn has four principal rafter trusses. The overall visual effect of the roof along with the log walls is almost mediaeval in appearance.

In the basement are seen two barn length (end wall to end wall) summer beams or timbers at the ceiling level. The summer to the north is supported by posts two of which are original with absolutely unique gun stock aspects along the top two feet or so of the posts. The gun stock areas that flare out join both the summers themselves and also the overhead transverse ceiling joists. All other original supporting basement posts in other bank barns in Pennsylvania have straight sided non gun-stocked sides. It is easy to see that the builder of this barn had the full intention of rendering the barn with the greatest level of structural stability that he could.

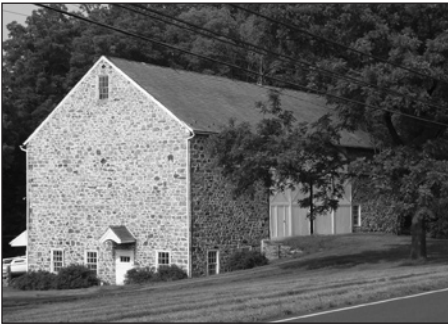
**English Lake District all stone bank barn, Circa 1830**

At the intersection of Routes 412 and 212, less than a mile east of the Village of Springtown, Bucks County, is the excellent and very large Funk-Spears English Lake District all stone bank barn. The very large outside dimensions—about 80 feet at the front and rear walls and 39 feet at each end or gable wall reflect a farm that must have been extensive in size. The barn appears to date from about 1830 to 1840. Two features seen on the exterior of the barn bespeak an English origin. The first is the all stone—from top of second floor to the ground of the front wall. Second—the basement level pent roof or short protective projecting roof that extends across the full length of the front wall of the barn. The first feature is always seen and the second feature (not original in the Spears barn) is almost always seen in English based bank barns in Pennsylvania. Seven stable doors appear below the pent roof in the Spears barn although none of them are original.

The interior of four-bay construction is cavernous and is of very similar size seen in the Oberly (see below) barn. Enormous amounts of farm crops could be stored in the Funk barn. The barn also features an English type Principal Rafter system where five principal rafter trusses are present. Two tiers of barn length purlin plates appear at each roof slope. These plates support the roof covering and extend from one end wall to the opposite end wall. Three built-in ladders one per bent or main transverse timber framed unit are seen.

In the basement are two summer beams—the front one is spliced—that is—made of two timbers that meet in end-to-end fashion. The one section is about 55 feet in length. One can only imagine the tree that was the source of this timber. The rear summer is spliced at two points, thus there are three lengths of timbers that constitute the rear summer. As in all barns, summers support the floor above the basement level.

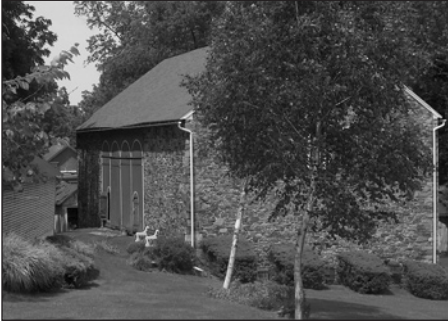
### Stone Standard barn, Dated 1849

This dated 1849 Stone Standard barn located on Meadows Road a little west of Saucon Creek rivals the Funk and Oberly barns for sheer size. This is the only dated barn on the entire tour. Standard barns are two level banked barns that have symmetrical roofs—that is—each roof slope of half of the total roof are equal in lengths. In addition, Standard barns have recessed stable walls such that the overhead basement ceiling joists or beams cantilever over and beyond the sill at the top of the stable wall. The great or perhaps even the vast majority of barns in Northampton County are Standard barns.

Stone appears to the peak at each end wall in the Wagner barn. This is a very well constructed barn. The front or “fore-bay” wall basically faces the southeast quadrant as the majority of bank barns in southeast Pennsylvania do. Much or most of the one threshing floor door retains its originality. Excellent and rare Moravian like wrought metal hinges appear on the human doors that are contained within each main threshing floor door. At the near end wall (closer to the brick house) are two side by side doors with original overhead door hoods. One was a feed entry door (*foodergong*) and one was an entry for horses. At the front stable stone wall are seven double Dutch doors most of which are original.

The interior of the barn on the second floor afforded tremendous storage capacity. The roof system again is an English based Principal Rafter type. As seen in the Funk barn there are five principal rafter trusses. Very large trees supplied the timbers that formed the principal rafters. This is a very late dated barn for the inclusion of a Principal Rafter system. Most often, this rafter type is seen in barns dating before 1830 or so. There are also double tiered purlin plates in the Wagner barn. The timber frame bents that flank both wagon bays consist of very well formed timbers and reflect a high level of craftsmanship. Mow-stead walls or boarded walls that appear at the lower parts of the bents consist mostly of original boards. These walls contained farm crops in the end bays or mows. Much of the interior surfaces of the stone walls are finished with plaster—a not unusual treatment.

In the basement, the overhead ceiling joists are of good size. Two summer beams appear and both are spliced. Original supporting posts appear below the summers. The basement retains in general a good level of originality that includes evidence of an original staked manger and manger trough. Not all barns retain this last feature. There are other interesting elements of construction and fabric to be seen in the barn. Current owner Gerald Holum is rightfully very proud of his barn.

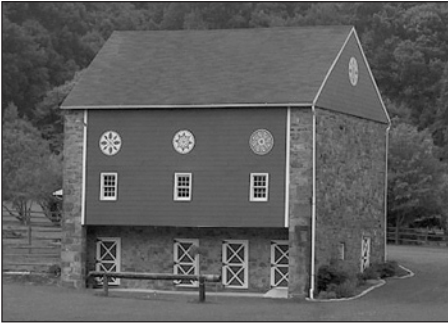
## **7 - Windsong Farm**

This beautiful picture post card barn located on Lower Saucon Road less than a half mile below the four corners of Wassergass is the smallest barn on the tour at only about 33 feet at the front wall and about 27 feet at each end wall. The barn, however, is in excellent condition and is very well maintained. This barn of three-bay construction likely dates to circa 1830. It is a stone to the peak (originally) Standard bank barn. There are four stable wall door openings. The doors are not original but the door frames are original and are very likely chestnut. As is typically found, there is a feed alley door entry at the end wall closer to the house. In the great majority of Pennsylvania bank barns the horse stabling area in the basement was closer to the house end. This may have been due to the fact that the farm lane was closer to the house and there was a greater need of accessibility for horses to be stabled toward the house end of the barn. Cows were most often stabled away from the house end. This was very likely the case in the Robertson barn in most of the nineteenth century and likely into the next century.

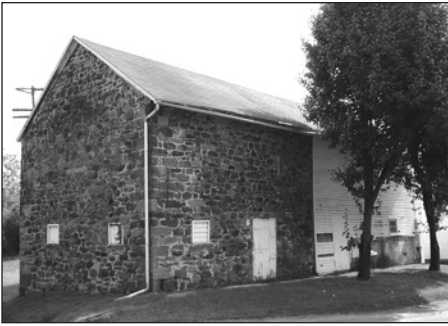
### Ground Barn, Circa 1800

At the Wagner Grist Mill site on Walnut Street (Skibo Road) in the Borough of Hellertown is an early style ground barn. In German, this barn style is referred to as a *grundscheier*. It is actually of combination stone and frame construction. It is difficult to determine when the barn was constructed but it may be circa 1800. The stone section is definitely original but the frame section may not be. Nowhere else in southeast Pennsylvania is there known an original condition stone and frame ground barn such as that seen at the grist mill site. The dimensions of the entire barn is—end walls are each 22½ feet long and the side walls are each 55 feet long. For a ground barn, this is a good sized building. Ground barns were un-banked structures of basically one level. They were most often of three-bay construction where one end bay stabled horses and the other bay stabled cows. Above each of the stabling areas were mows for crop storage. Between the end bays was the middle or threshing bay.

The stone end section at the railroad end of the barn is 23 feet long. The remaining 32 feet length of the barn is the frame construction end. At the stone barn section stone appears to the roof peak. At the stone side wall closer to the main road there is a stable door opening that leads into the horse stabling area. At the opposite stone side wall there were originally two stable door openings, one of which was filled with stone at an indeterminate time. The existent door opening is original but the door itself is not likely original while the door frame is.

At the end wall of the frame section appears a 7 ½ foot high stone wall section from the ground up that might well indicate that this end of the barn was also originally entirely of stone construction. Large quoins or corner stones can still be seen at this end wall.

The interior of the barn still retains a fair amount of its original timbering especially the roof timbers that includes the hewn rafters. This is the first barn that apparently had an original Common Rafter system where rafters are of the same basic size. Still, much of the interior of the barn has been sacrificed through the years. One specific area that retains a great deal of its original fabric is the area at the rear stone side wall where the door opening has evidence of a horizontal sprigge bar that was placed across the stable door opening to contain horses at night. To the right of the door opening is a curry box set into the stone wall that contained items incidental to the maintenance of farm horses. Close to the box is a beam also set into the stone wall that held wood pegs or hooks for placement of harnesses.

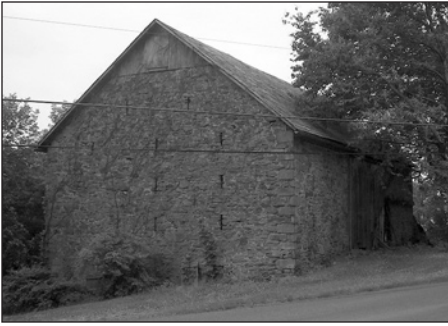
## 9 - Seifert Homestead

This barn displays a Principal Rafter system and two principal rafter trusses appear. Only one tier of purlin plates are seen on each roof slope. The wagon bay has most of its original threshing floor planks intact. It appears that there is the very rare condition of a granary at the front or fore-bay wall in each end bay. The appearance of a double granary is especially unusual in view of the fact that the barn is a rather small structure. Occasionally very large barns are in need of great storage areas because of great farm acreage under tillage. Both original mow-stead walls are mostly intact and boards of the wall appear to be secured with early type nails. Both bents that flank the wagon bay have built-in ladders. Perhaps because of its relatively small size just one summer beam appears in the basement.

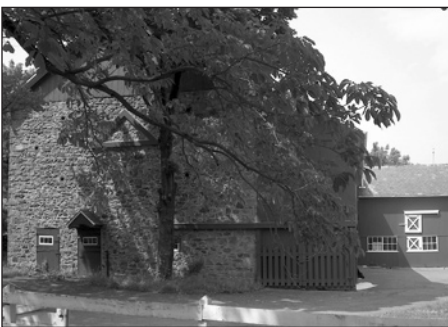
### Stone Standard barn, Circa 1830

The Casilio homestead barn on Route 412 (Leithsville Road), one-half mile from the Bucks County line, is yet another Stone Standard barn. It too is of three-bay construction. The barn is of medium size seen in its exterior dimensions of 60 feet at each of the front and rear walls and 37 ½ feet at each end wall. The barn was likely built in the late 1820s or so. It appears that construction of the barn took place under the homestead ownership of

Samuel Solliday after the death of his father Jacob Solliday in 1827. The near end wall (closer to the main road) has circular brick lined loopholes. Very strangely the opposite end wall and far section of the rear wall has none of these loopholes. The appearance of loopholes is almost exclusively confined to the eastern Lehigh Valley and a bit in northern Bucks County and also in extreme west-central New Jersey. The near end wall has two door openings—one a *foodergong* and another is an animal entry. The one has an overhead door hood that appears to be original with a very faded imprint of a barn star (hex sign) on the front.

Almost dramatically the barn has a distinctive Principal Rafter system and it has four principal rafter trusses. Two tiers of full barn length purlin plates appear on each roof slope. Each bent that delimits the wagon bay has a very much off-centered built-in ladder which is quite an unusual feature. Both original mow-stead walls are mostly intact and one of the walls has a non-original door with very distinctive carvings with the name of J. A. Solliday—Bingen PA and date of May 1st 1909. Other carvings appear. The Solliday family or extended family occupied the homestead from about 1805 to 1941. The earliest private land purchase of nearly 170 acres from the Penn family was made by Adam Failor (Fehler) around the year 1760. The original land survey made in December 1737 entailed 607 acres from which the Failor land originated. This land was warranted in January 1734/35. Most of the original second floor or loft level timbering of the Solliday barn remains while almost all of the authentic wagon floor with its original planks also remains.

Attached to the front of the barn is a much later built straw shed. It demonstrates mortise and tenon joinery. The frame building at the front of the combination main barn-front straw shed is of much later twentieth-century construction.

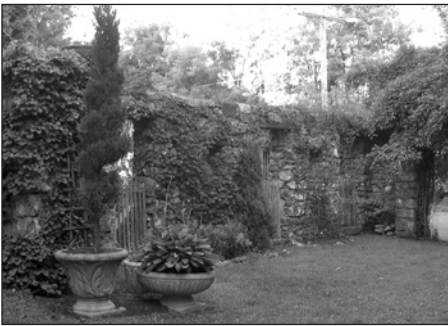
## 11 - Ehrhart's Mill Historic District

At the very end of Old Mill Road and very close to Saucon Creek is a barn ruin that has been converted to a garden. Only the stone basement walls of the barn remain and within the confines of the basement area many wonderful flowering plants can be seen. The garden almost appears like a well arranged forest as the plants are so densely arranged. This is an excellent example of adaptive re-use. This homestead is part of the Ehrhart's Mill Historic District.

The structure was a two-story Standard banked barn and very likely it was of frame construction above the basement level. A late 1980s historic report states that the barn was of three-bay construction. The barn that collapsed down to the foundation in the 1970s very likely dated to post 1850 or even after the Civil War. It measures about 34 feet long and 27 feet wide. A few original remnant wall openings can still be seen. Vestiges of the stone stable wall can also be seen. The house on the property is brick and there is a good stone bake oven in the rear yard that may be seen from the garden area.

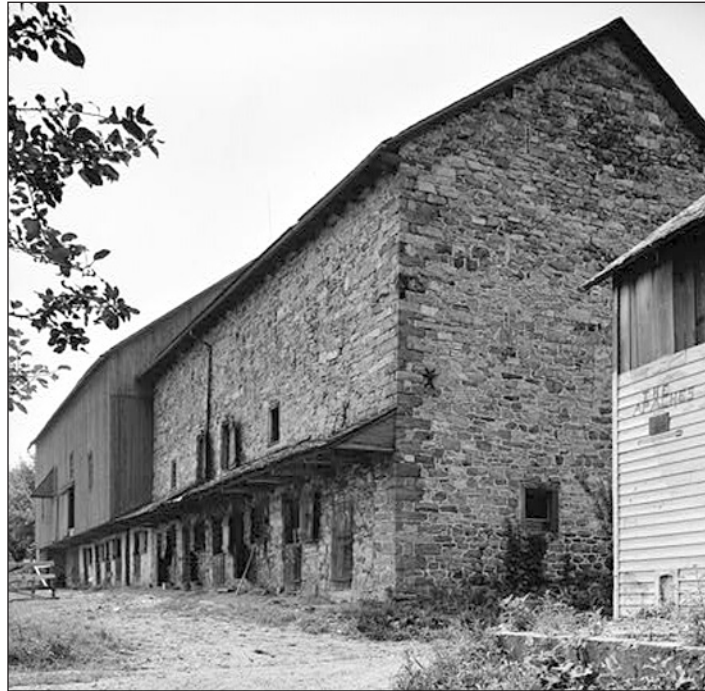
*This is the original early 1940s photo of the Heller homestead barn complex that consisted of two end to end sections. A circa 1790 English Lake District barn with a stone addition with an unusual front wall stone arch appeared at the north end and a large Civil War era frame section was at the south end.*

The money raised today will be earmarked for the preservation and restoration of the Michael Heller Barn. Until February of 1998, all four sides of the original stone barn stood erect. In the aftermath of a severe storm, a portion of the barn collapsed. Deeming it a danger, township officials decided to bring down all but a small section of the stone walls of the barn, preserving its very unusual arch.
